Interior Motive: Insulation & Trim Panel Installation, Project F2

by Jim Keliher

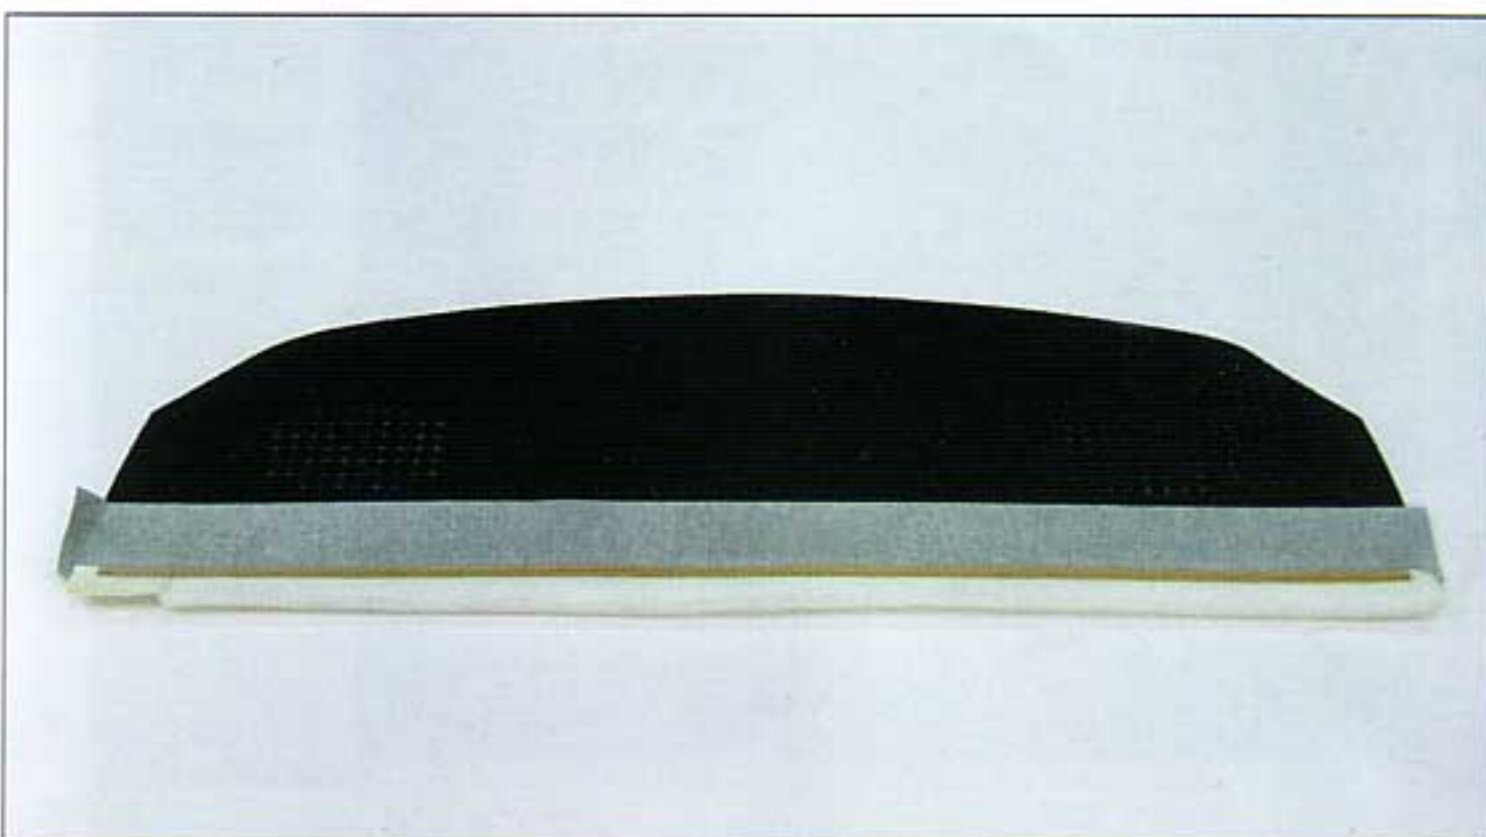
Photo #1

The first order of business was to install the black standard rear package tray, **part #746024 (photo #1)**. This was done by spraying the rear bulkhead with Sticky Stuff spray adhesive, **part #49-22 (photo #2)** then spraying the fabric on the package tray as well (**photo #3**). The package tray was then slid into place under the rear window and the fabric was pressed onto the bulkhead (**photo #4**).

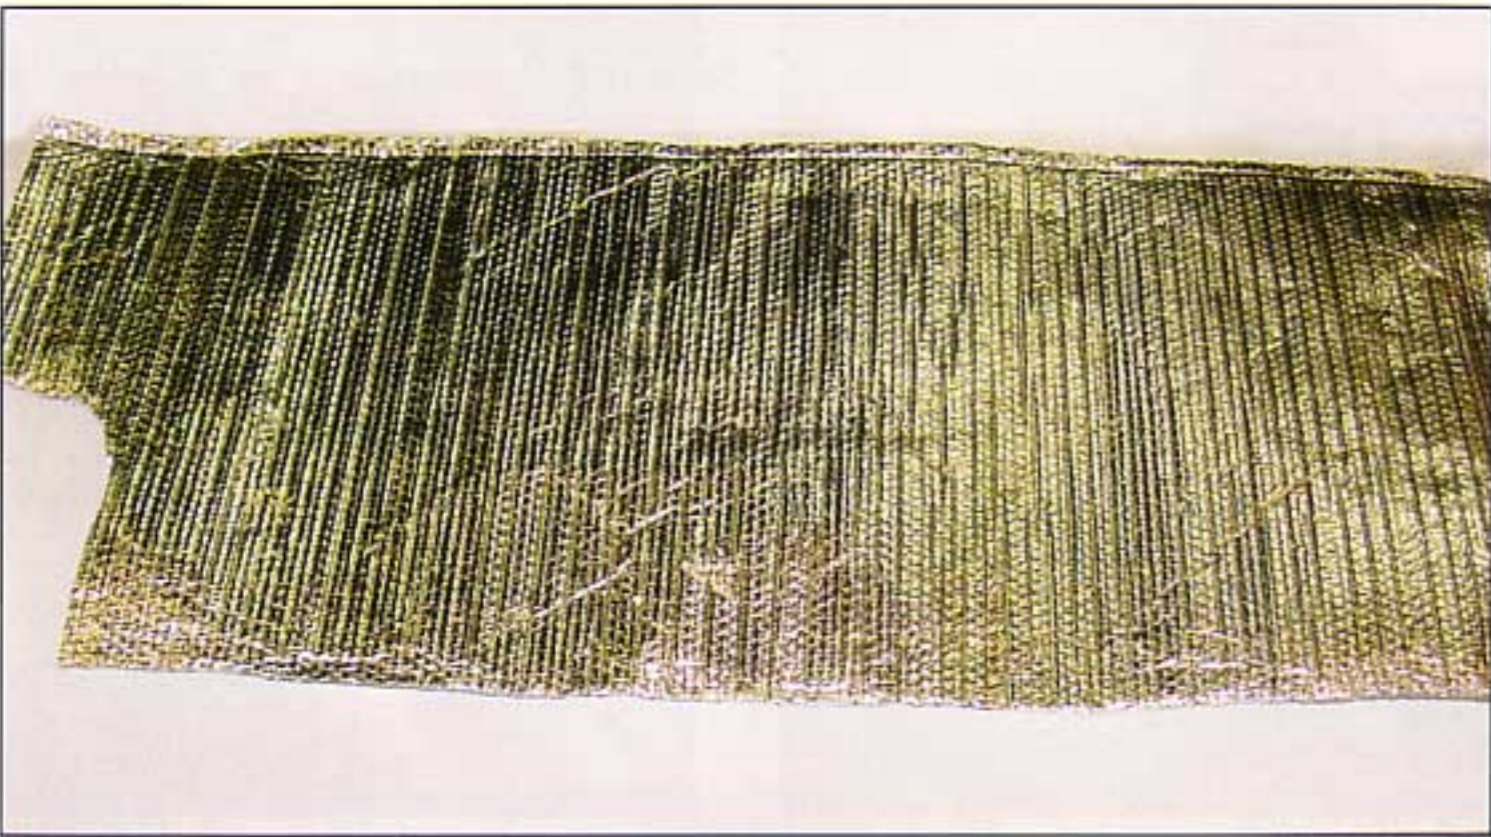
Photo #5

We again used "The Insulator" insulation sheets, **part #14-27**, to cover the rear bulkhead and wheelhouses. We took some rough measurements and cut the insulator sheet larger than we needed, and trimmed the passenger side to get the installation started (**photo #5**). We then sprayed the adhesive on the bulkhead and the back of the insulation. The insulation was then rolled into position and then trimmed with a utility knife. We began with the wheelhouses by measuring the distance from the bulkhead to the floor along the top. We again rough cut the insulation, and sprayed both areas with adhesive. This allowed us to attach the insulation along the top of the wheelhouse (**photo #6**). The insulation was then folded down with "pie cuts" removed to eliminate the uneven areas. The insulation was then smoothed into place and duct tape was used to seal the seams (**photo #7**). This same procedure was then repeated on the other

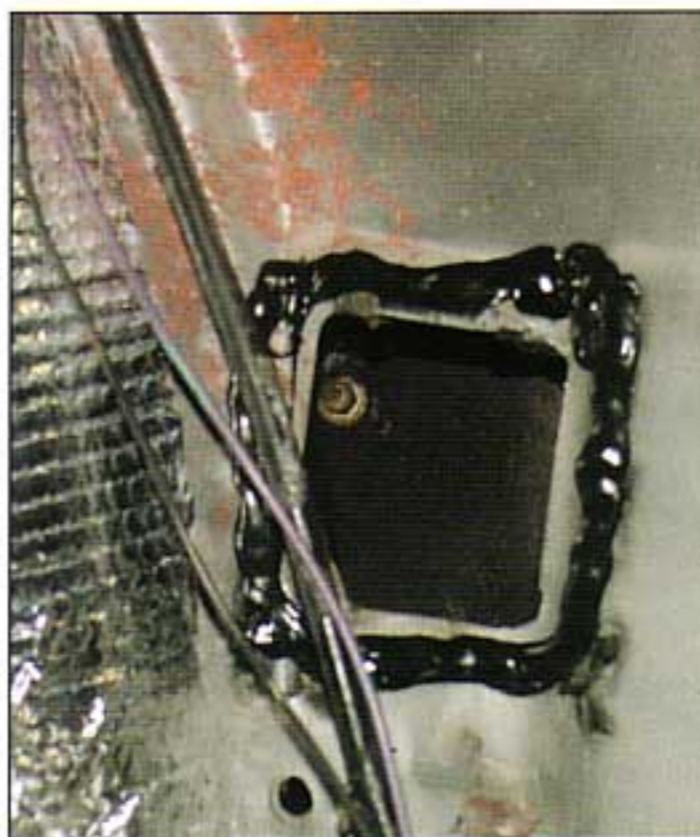
Photo #8

side of the car. We noticed that the interior quarter panel had an inspection hole that needed to be sealed. The only purpose we could find for this hole was to install the side spoilers, but found the nuts could be better accessed through the door jamb vent. We elected to cut a piece of insulation and using glass and body sealant, **part #49-08**, we ran a bead around the opening (**photo #8**) and around the insulation (**photo #9**). We then stuck the pieces down on both sides (**photo #10**). The insulation for the quarters was cut oversize, glued, and stuck into position the same as the previous insulation. It too was final trimmed with a utility knife (**photo #11**) and the joints were again taped with duct tape (**photo #12**).

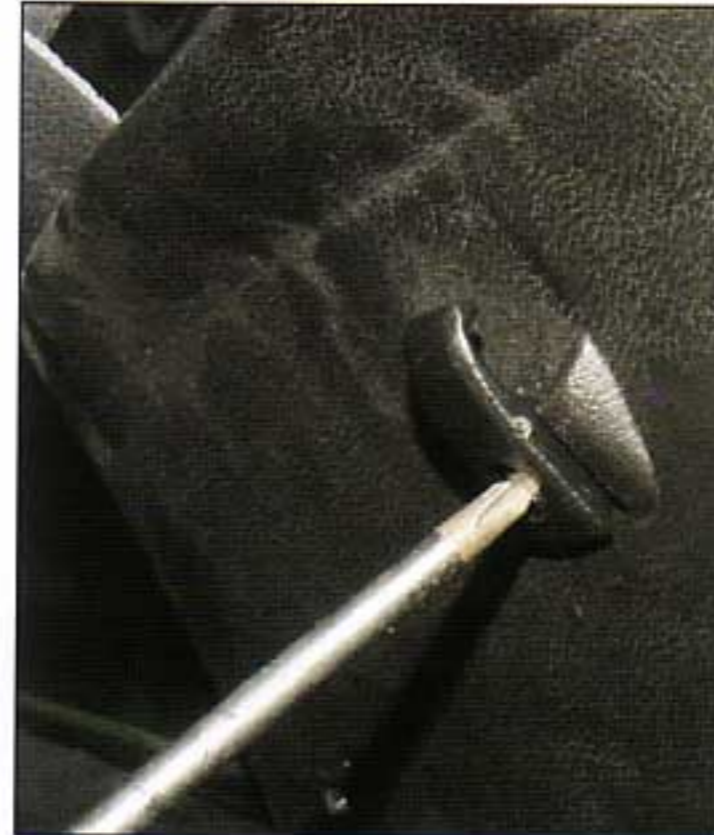
Photo #17

(photo #14), the upper trim panel metal tab was slipped under the rear window channel, while the bottom tabs were slipped behind the lower panel. The front edge was also slipped over the door jamb pinchweld, and the upper trim panel was in place. The panel is held in place with two #8 x 1" trim screws (photo #15) and the coat hook, part #707030 (photo #16). The coat hook is held in place with a #8 x 1 1/2" trim screw (photo #17). All we had left was to install the rear seat belt retractor (photo #18) and the latch (photo #19), then install the rear seat cushion (photo #20). This same procedure was repeated on the right (passenger) side. We are very happy with the result, and feel you will be too (photo #21). Good Luck! 🍀

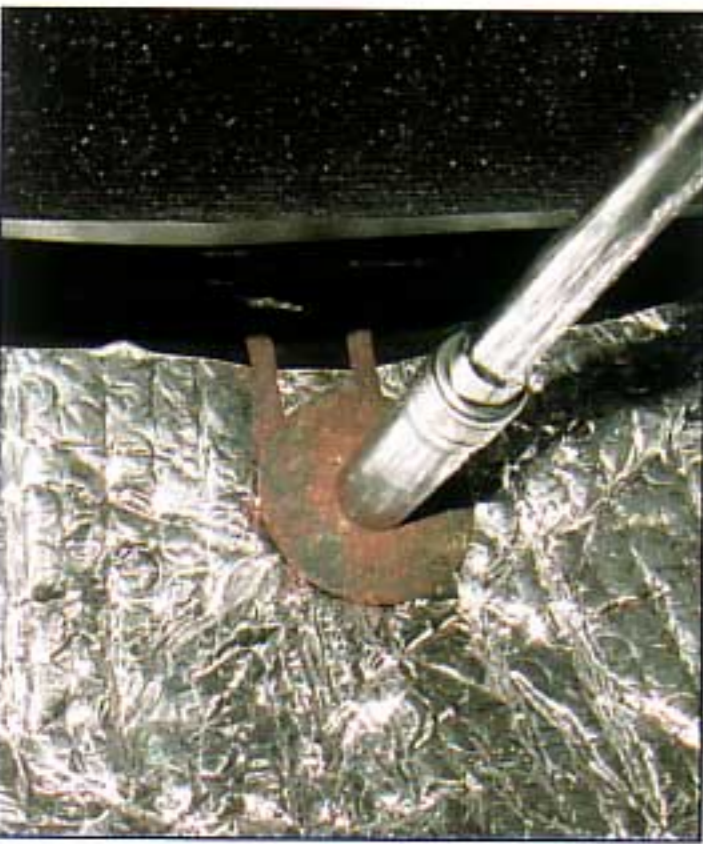
Photo #13

The rear seat back was then installed by guiding the top onto the hooks attached to the rear bulkhead. The bottom was fastened into place with the original #14 sheet metal screws by using a 7/16" socket (**photo #13**). We painted all of our new panels to match the color of our interior, then installed the upper quarter trim panels, **part #707296**, right, and **part #707295**, left. Then installed the lower ones, **part #707156**, right, **part #707153**, left. The left lower trim panel was placed into the car by hooking the lip over the door jamb pinchweld. There are two locating tabs welded to the floorpan that keep the panel from going too far in. The lower panel has a hole in it that lines up with one of these tabs, but there was no evidence of a screw being used, so we left it out also. With the lower panel installed
